Sustainable Rehabilitation of a Highway Slope Failure with Geosynthetics

ABSTRACT: This paper presents a novel solution by taking into account of safety and sustainability to cope with a damaged slope. The rehabilitation consists of a piled supported reinforced concrete protection wall and a reinforced soil slope (RSS) with geosynthetics. Such approach is not common; however, the experience described herein has shown that the reported composite retaining structure meets all the site criteria. RSS demonstrated competent safety and significant carbon footprint reduction compared to those of traditional reinforced concrete structures. RSS also successfully made a vegetated terrain that has presented a natural appearance and provided an aesthetic and eco-friendly environment for the site. Based on field observations, the slope is stable and safe to date. It is a valuable and sustainable solution particularly for those sites that have a major concern with basal instability due to scouring effect.

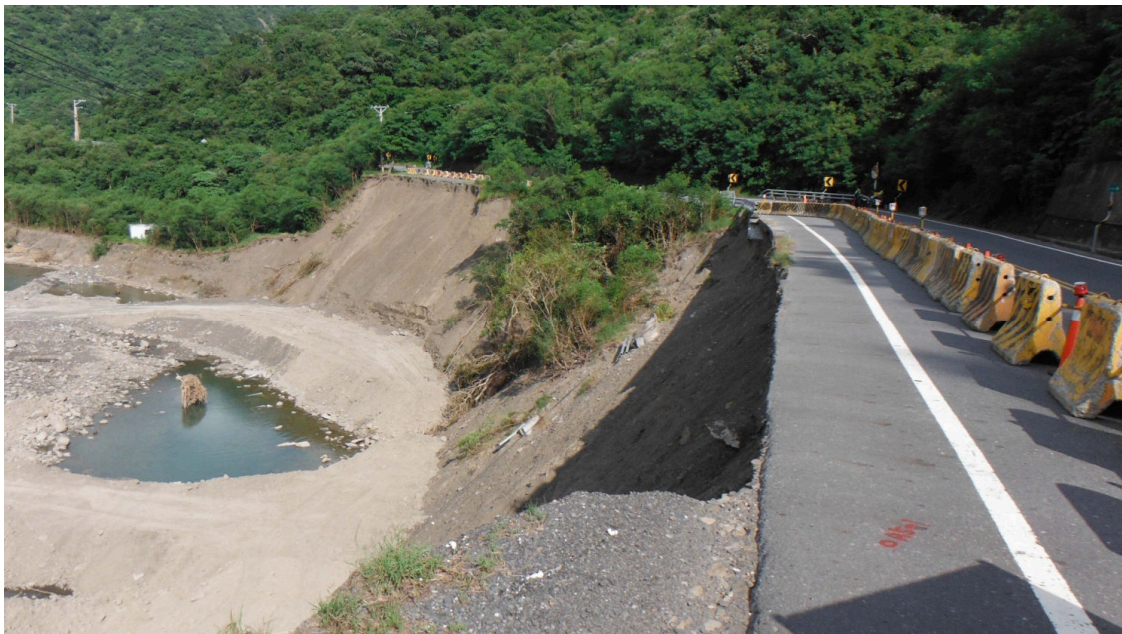
The depth of the slope was over 20 m and the toe was vulnerable by the attack of the adjacent river. There were tons of rubbles on site because of the collapsed debris and they must be used as much as possible for construction as the highway managing authority required the rehabilitation should be a sustaina-

Figure 2. Severe scouring smashed the riverbank and caused disruption of the highway.

Route 9 is the most important arteries in southern Taiwan with world-famous natural scenery along the line. In August 2013, Typhoon Kongrey hit the island with heavy rainfall and caused numerous infrastructure damages in these areas. As shown in Figures 1~2, the site reported herein located at Sta. 470k+500 where its downslope was totally collapsed due to the riverbank breach which was smashed by the rushing flooding of the adjacent River. The in-situ drainage system also was found insufficient to accommodate the enormous overflow came from the upper land of the site. The highway was seriously disrupted and the rehabilitation was immediately necessary to resume the normal livelihood of residents and minimize the loss of local tourism productions.

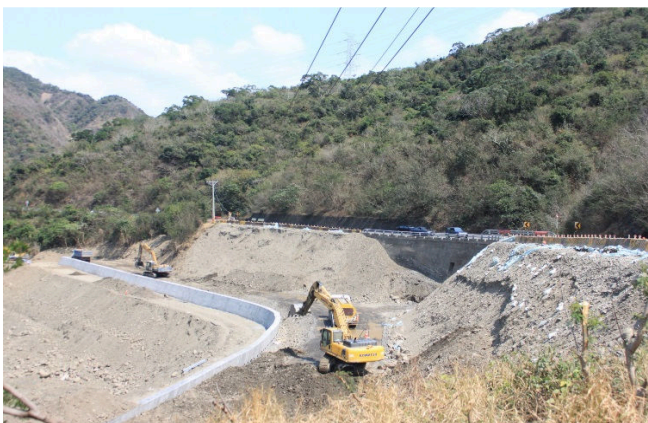
(a) Construction of pile-supported protection wall.

Figure 4. Slope rehabilitation under construction.

As shown in Figure 4, the final construction for the rehabilitation consisted of two parts. In part I, a 150m long, 12m high, pile-supported reinforced concrete waterfront protection wall was built for the lower part of the slope below the highest water level (Figure 4a). The piles were installed with a diameter of 120cm and a minimum embedded length of 10m. A total of 115 piles, each spaced 2m, were installed in two rows with all-casing drilling technology and seated into the bedrock for at least 2m. The durable RC structure was used to prevent the instability from river scouring.

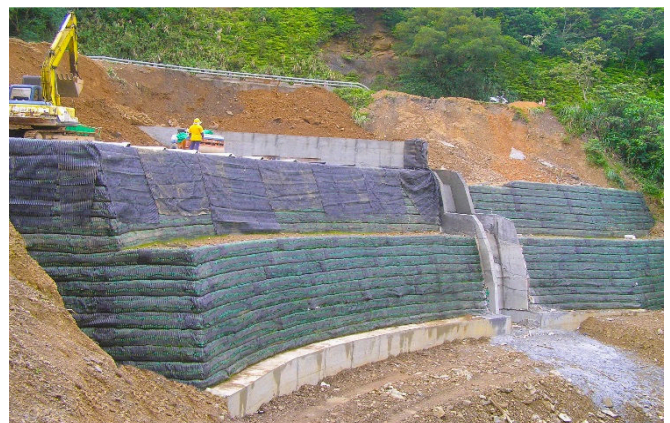
(b) Construction of reinforced earth slope.

In part II, a wrap-around reinforced soil slope containing geogrid, geobag, and geotextile drainage materials were chosen to restore the upper part of the slope (Figure 4b). The benched RSS was constructed with two steps using collapsed spoils piled on-site. Each step has a height of 4 to 6m with an averaged backward inclined ratio of 1:2 (H: V) so that a sufficient width of the highway can be maintained. Considering the safety and the cost, the lower part of the RSS applied stronger geogrid (Type A) as the reinforcing material for a total surface area of 1,326m². Another 995m² of Type B geogrid with lesser strength was used for the upper part of the RSS. Each layer of the fill material was installed with a vertical spacing of 50cm.

To prevent the surface overflow washing and softening the RSS, a 2m×2m approximately, drainage culvert was installed below the pavement to collect all the possible surface run-off and discharged it directly to the river. Stacked soil-filled geobags were used for slope face protection. It also functioned as the medium of planting as vegetated slope was not only good for an aesthetic appearance but also for an eco-friendly environment.

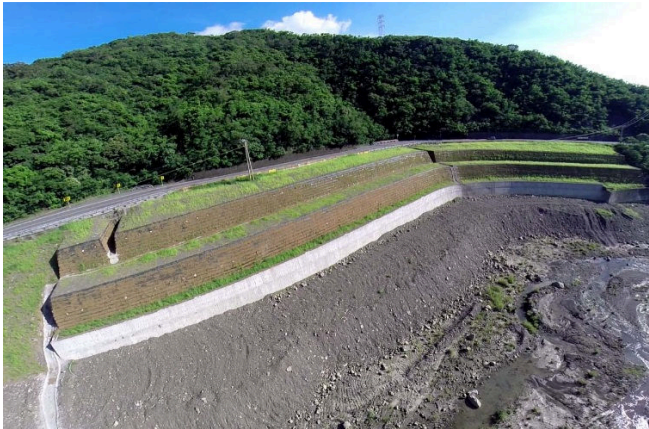
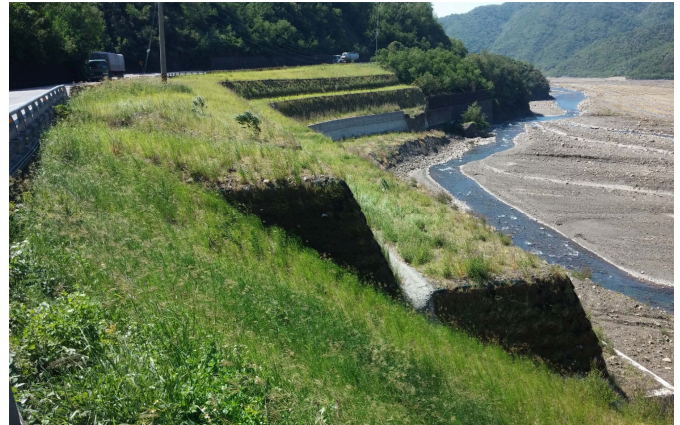
(a) End of construction.

(b) One year after the completion.

Figure 6. Completion of the rehabilitation.

After four months of construction, this project was successfully completed in May 2014. Since then it has been through a number of typhoons attacks and by far still remaining in good condition (Figure 6). Although it has always experienced heavy traffic, no evidence has been observed for deterioration or instability. Vegetated slope presents natural appearance and provides an aesthetic and eco-friendly environment for the site. As many other similar projects already in use, the rehabilitation has been proved successful.
