Application of Complex Reinforced Structure near Fault Zone

Author : ACE Geosynthetics

Reference : IFAI IAA(2011)

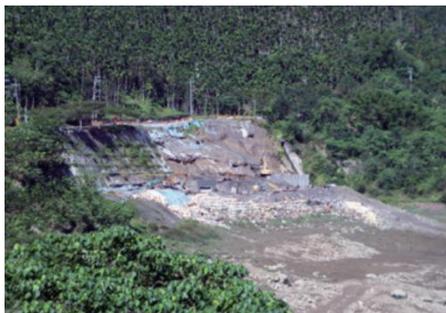
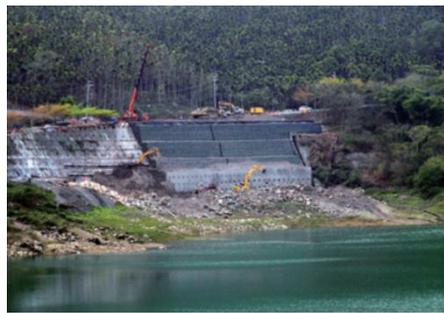
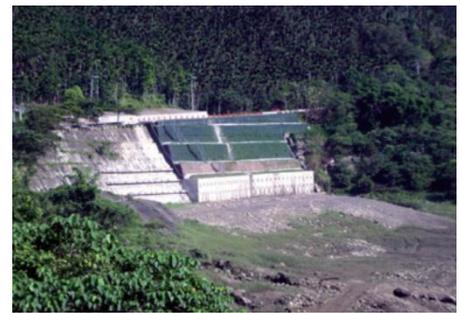
Located on County Route No. 131 in Taiwan, the regional geologic map shows that the several fault zones cuts through the job site area, rock mass is fragile and weak. A great landslide up to 80m wide and 30m high was caused by a torrential rainstorm in 2007. The existing anchored slope was severely damaged with main structure being pulled out and exposed after the landslide, forming a huge heave on the toe of the slope.

A design was adopted to drilling concrete piles of 1.5m diameter, 20m and 30m long installed every 2.5m beneath the 8.5m high of RC retaining wall. Three stages of soil anchors, bond length 10m, free length 30m, anchorage load 60t, were also installed from the wall surface every 2m both horizontally and vertically.

Above the RC retaining wall, wrap-around reinforced structure was constructed: 10m and 8m long of ACEGrid® installed within the structure, slope inclination 1V:0.3H, wall height 17m dividing into 4 stairs. A full interior and exterior drainage system was installed in the reinforced structure to effectively resolve the poor drainage problem.
